# 地面N1限制值不一致的快速处置

华北区域波音技术组（内部使用）

2022年8月18日

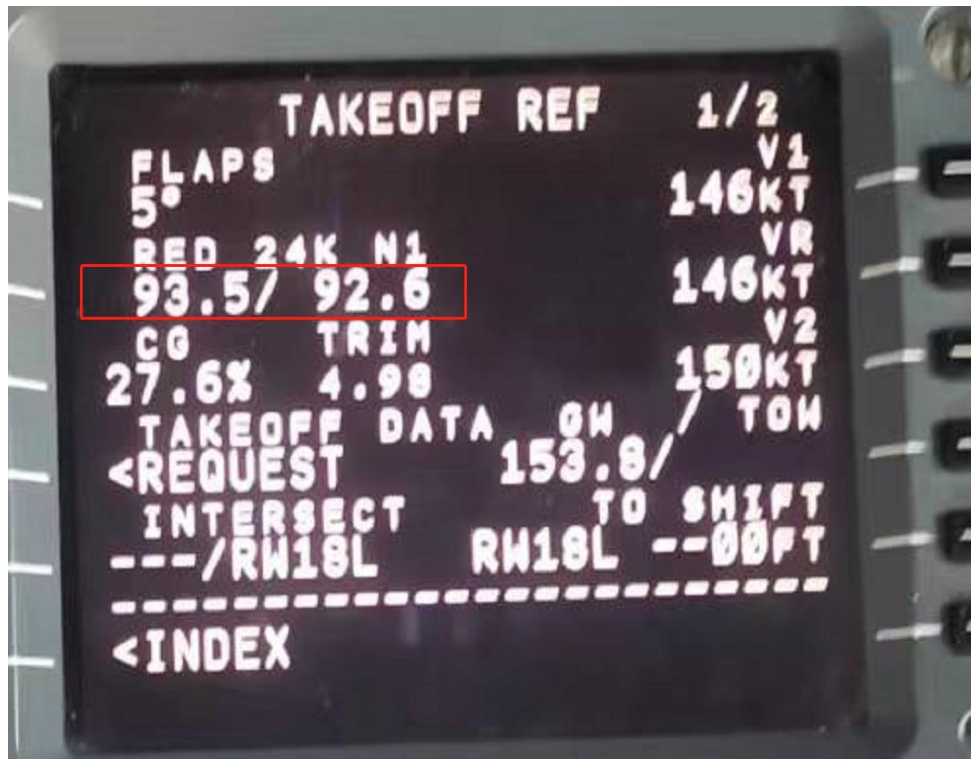
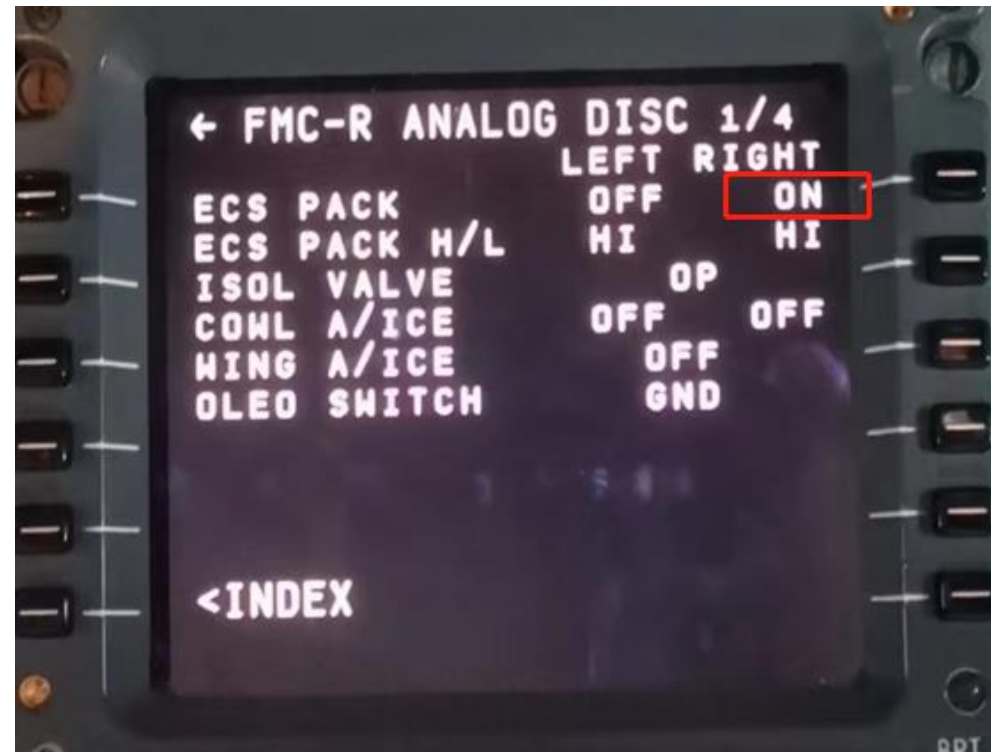
某飞机机组反应CDU起飞基准页面N1限制值不一致，检查发现右组件活门位置离散信号和实际电门位置不一致。因此虽然此时组件电门都在OFF位置，但因为右组件活门在电门在OFF位时离散信号在ON，左右不一致，最终导致N1限制值不一致。核实右组件FCSOV件号为396608-1，依据MEL 21-02-04A放行。

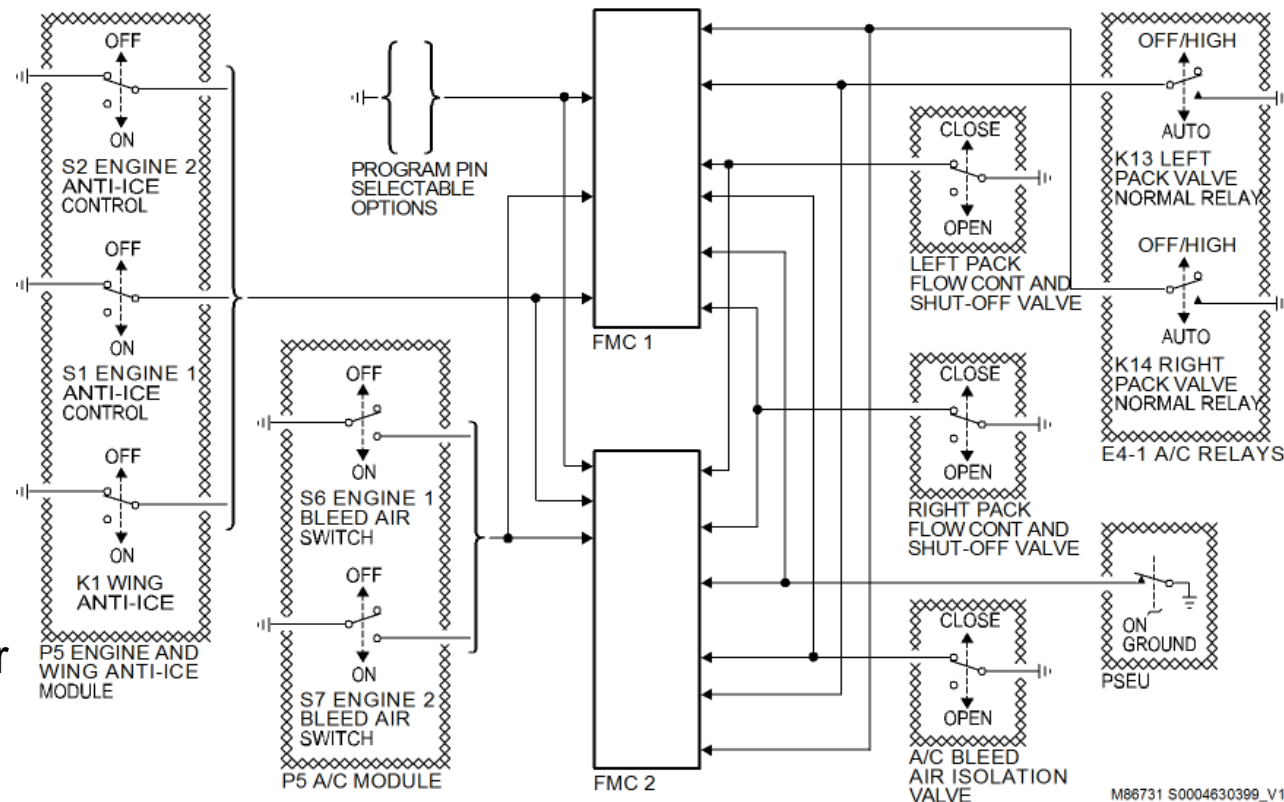
活门/电门位置（飞机的引气需求）提供给**FMC**，**FMC**根据引气需求计算**N1**限制值。

当飞机引气需求增加，**N1**限制值降低补偿引气负载的增加。例如，左组件活门**OFF**，右组件活门**ON**，右发**N1**限制值会低于左发

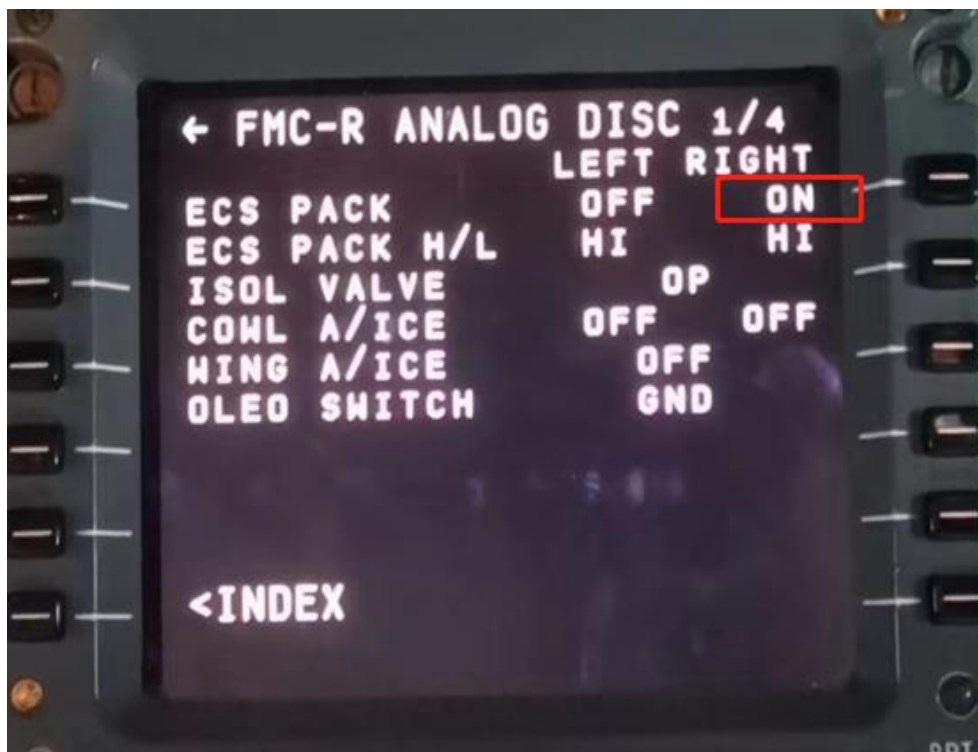
不一致

注：根据机队经验，故障主要是由组件活门位置离散信号失效导致。按需参考MEL 21-02-04A或21-02-04B处置。

接报故障后，首先确认左右组件电门位置、左右发动机进气道防冰电门位置是否一致，若不一致，将电门放置相同位置，并从CDU进入FMC页面，查看电门/活门位置是否一致。
