737NG货舱地板损伤处置与修理

海技北分区域波音技术组

2023.09.05

近期多架飞机出现货舱地板损伤，且安排调回北京修理。此类损伤日常比较常见，因此结合近期案例，将货舱地板损伤处置、补片损伤、修理方案等进行梳理介绍。

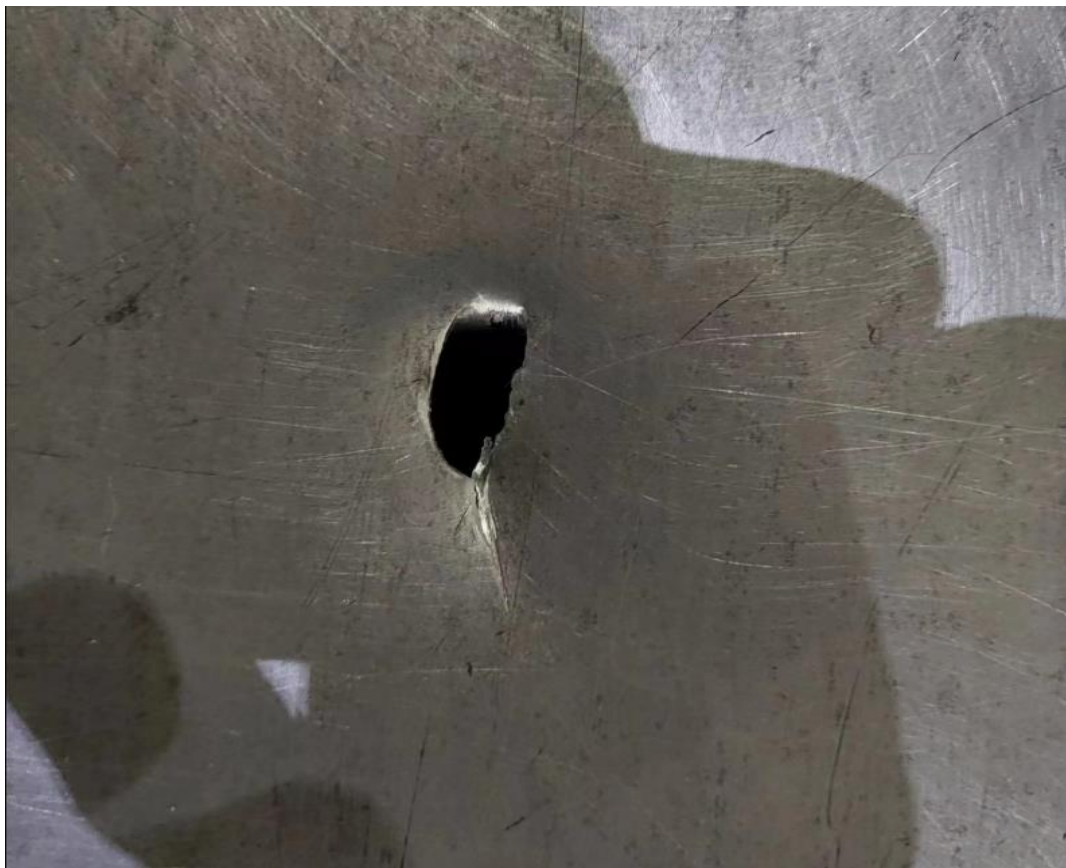
穿孔

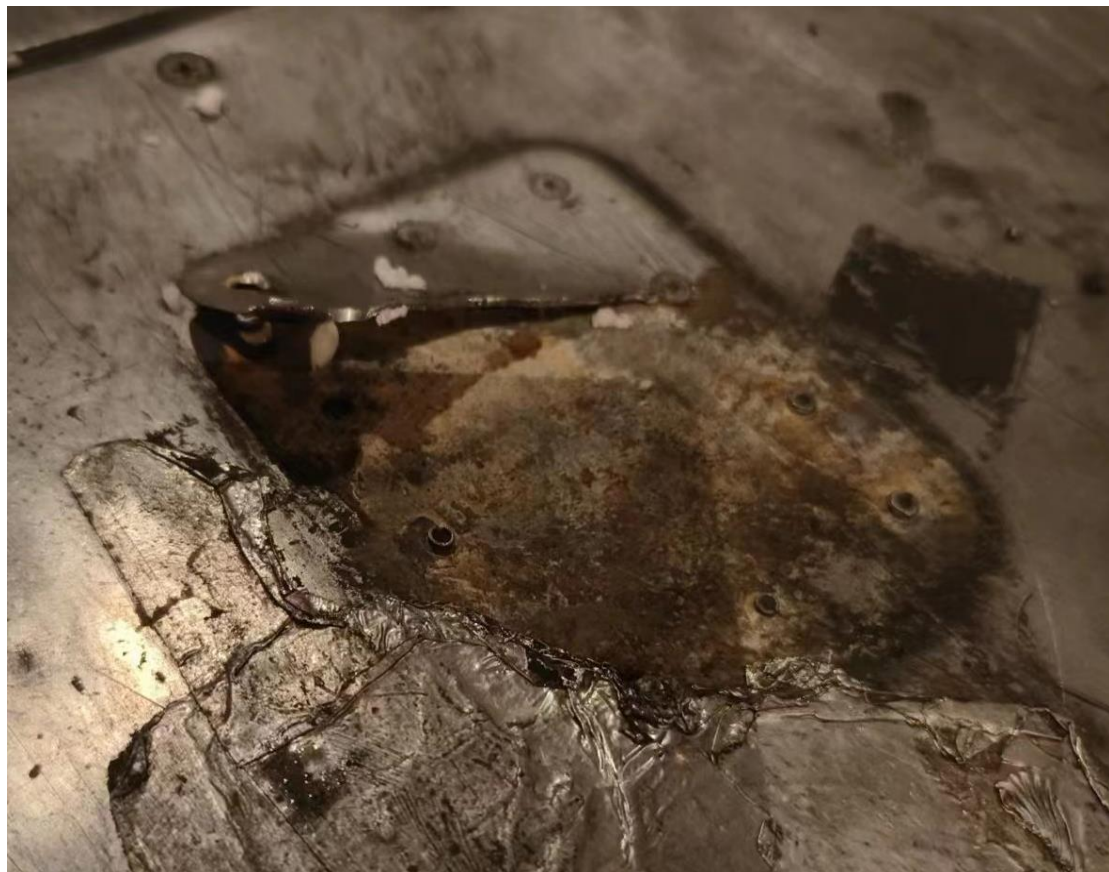
补片损伤

对于补片或修理区域再次损伤的情况，因当前部件状态不再是原始出场状态，不可以直接应用SRM进行标准核实，此情况需和结构工程师或厂家进行一事一议评估。

注：按目前经验，上述情况通报厂家的结果基本就是立即修复，厂家基本不会通过偏离申请。
