# **B-5538轮舱液压管漏油 (B-nut渗漏)**

**海技北分区域波音技术组**

**2023.09.20**

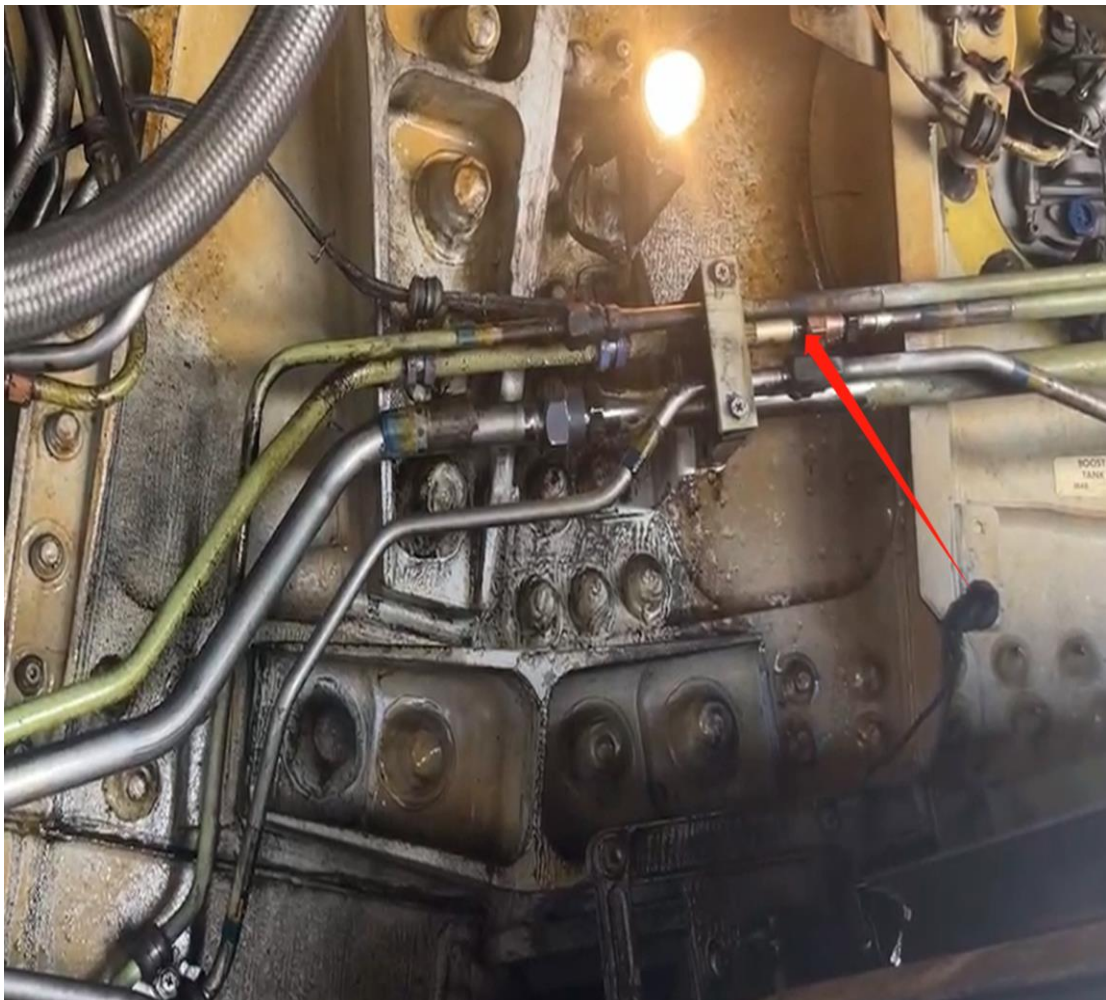
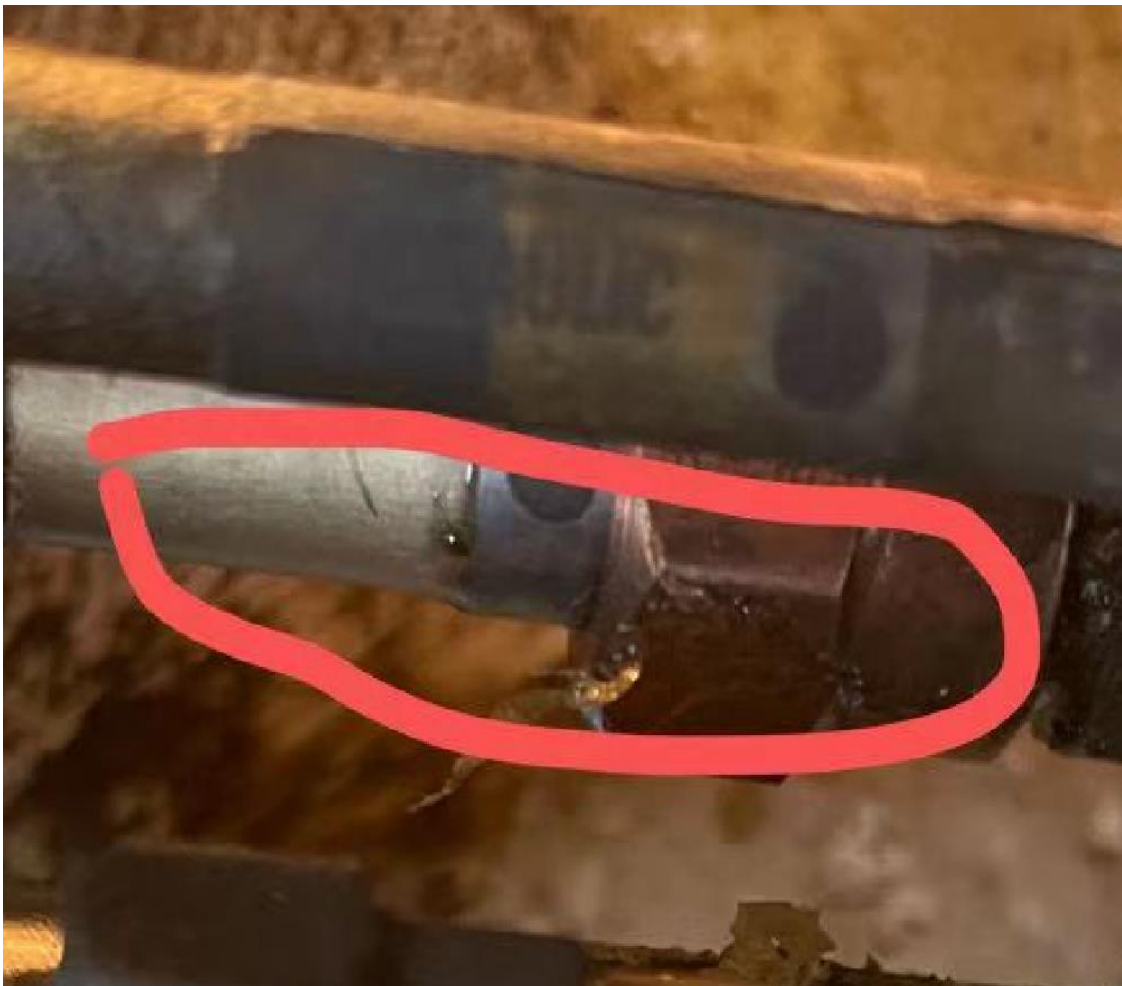
近期检查发现飞机轮舱一液压管接头处渗出液压油，重新完成力矩检查再次打压检查未见渗漏，航班正常保障。此类漏油比较常见，尤其是在冬季更为多发，因此将案例进行总结，积累处置经验，提高处置效率。

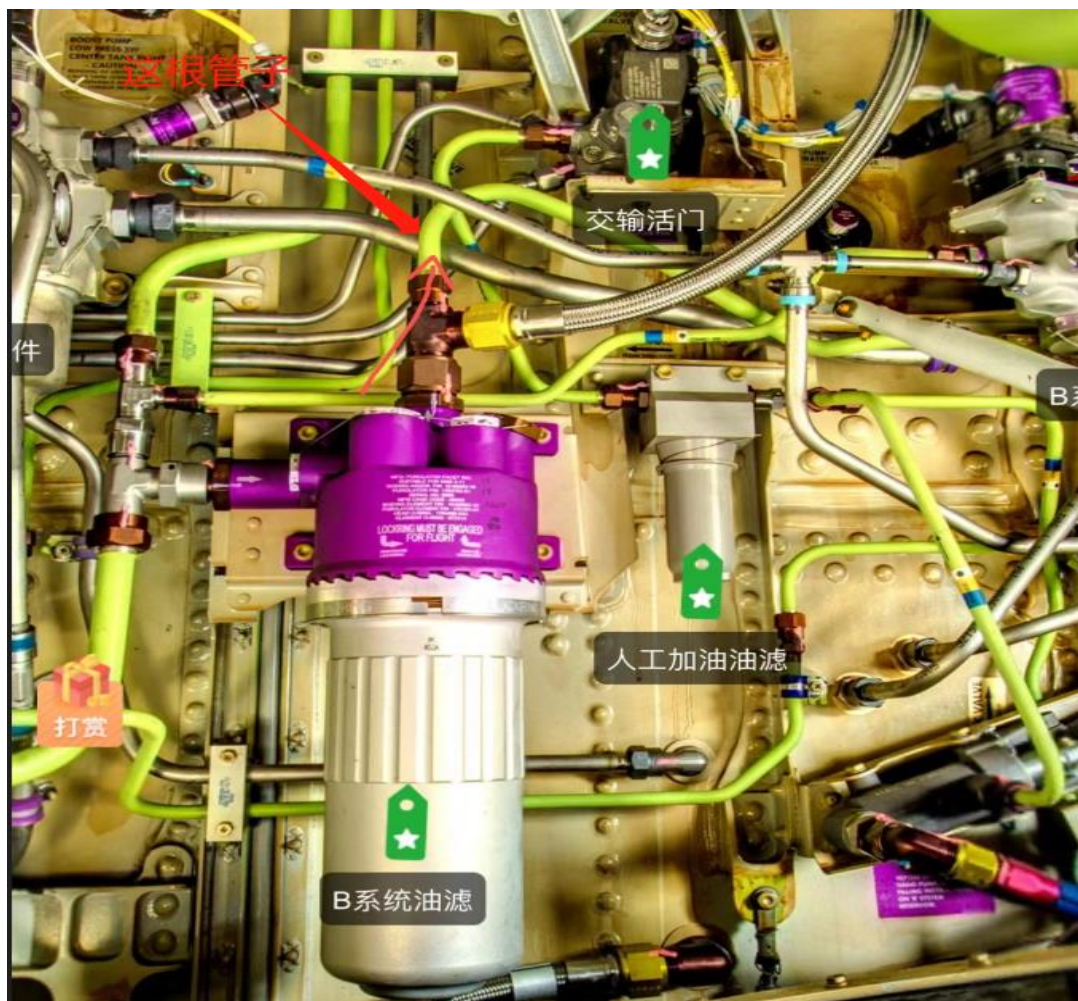
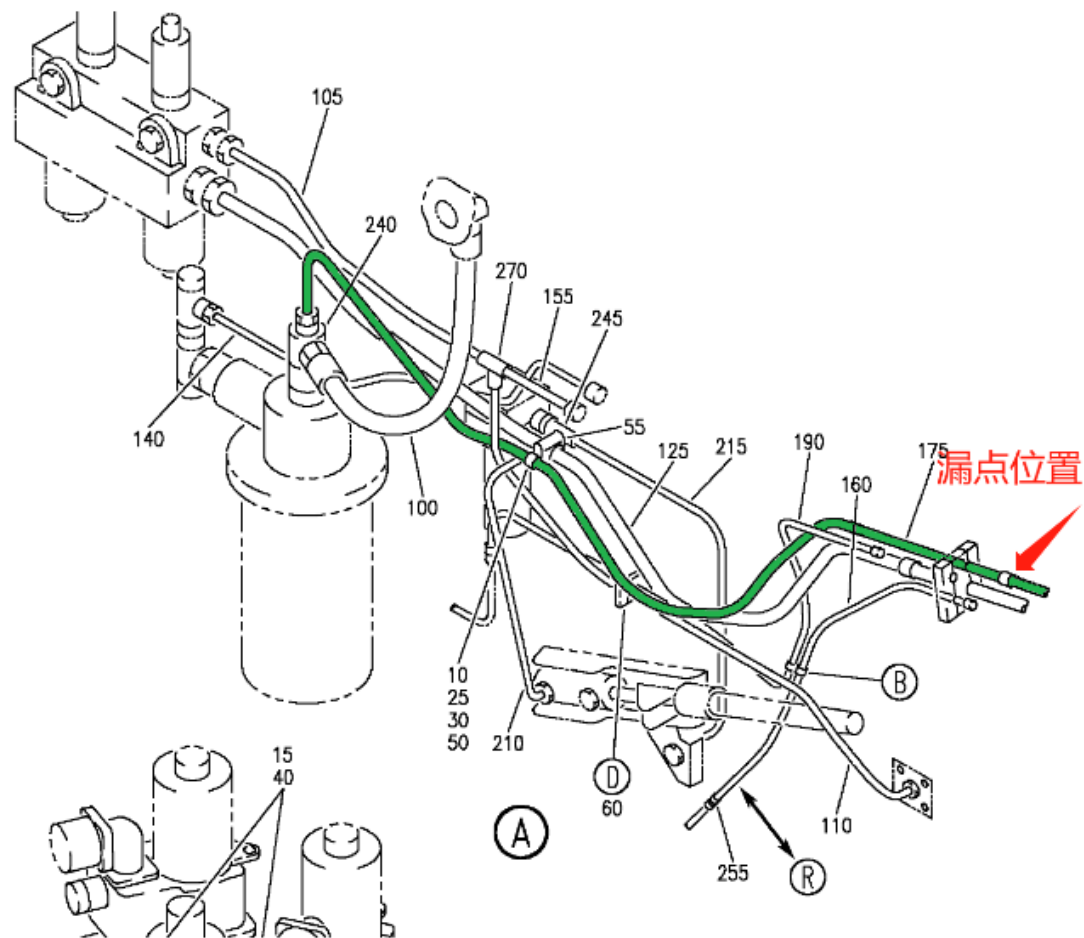
管路件号：272A4451-1080，是从B系统热交换器的回油路上过来的管路，漏点在管路B-nut连接处

依据上述标准，飞机无法放行，难道飞机因此AOG了吗？我们通篇阅读前述AMM AMM 29-00-00-790-801可以发现general部分有如下关键信息，从中我们可以知悉B-nut连接密封是通过金属件的贴合实现的，如果在正确力矩下渗流依旧，说明部件已经失去功能，需要立即更换。因此，只要对相关位置重新按正确力矩进行紧固，确认其不再渗漏，飞机就可以正常保障的。（注意：这里的前提是使用正确的力矩，而不是超力矩拧紧，否则会加速部件的失效）

在AMM 20-50-11-910-801table219找到力矩为280in\_lb。
