# 737NG LPTACCV气管损伤标准

海技北分区域波音技术组

2023.10.08

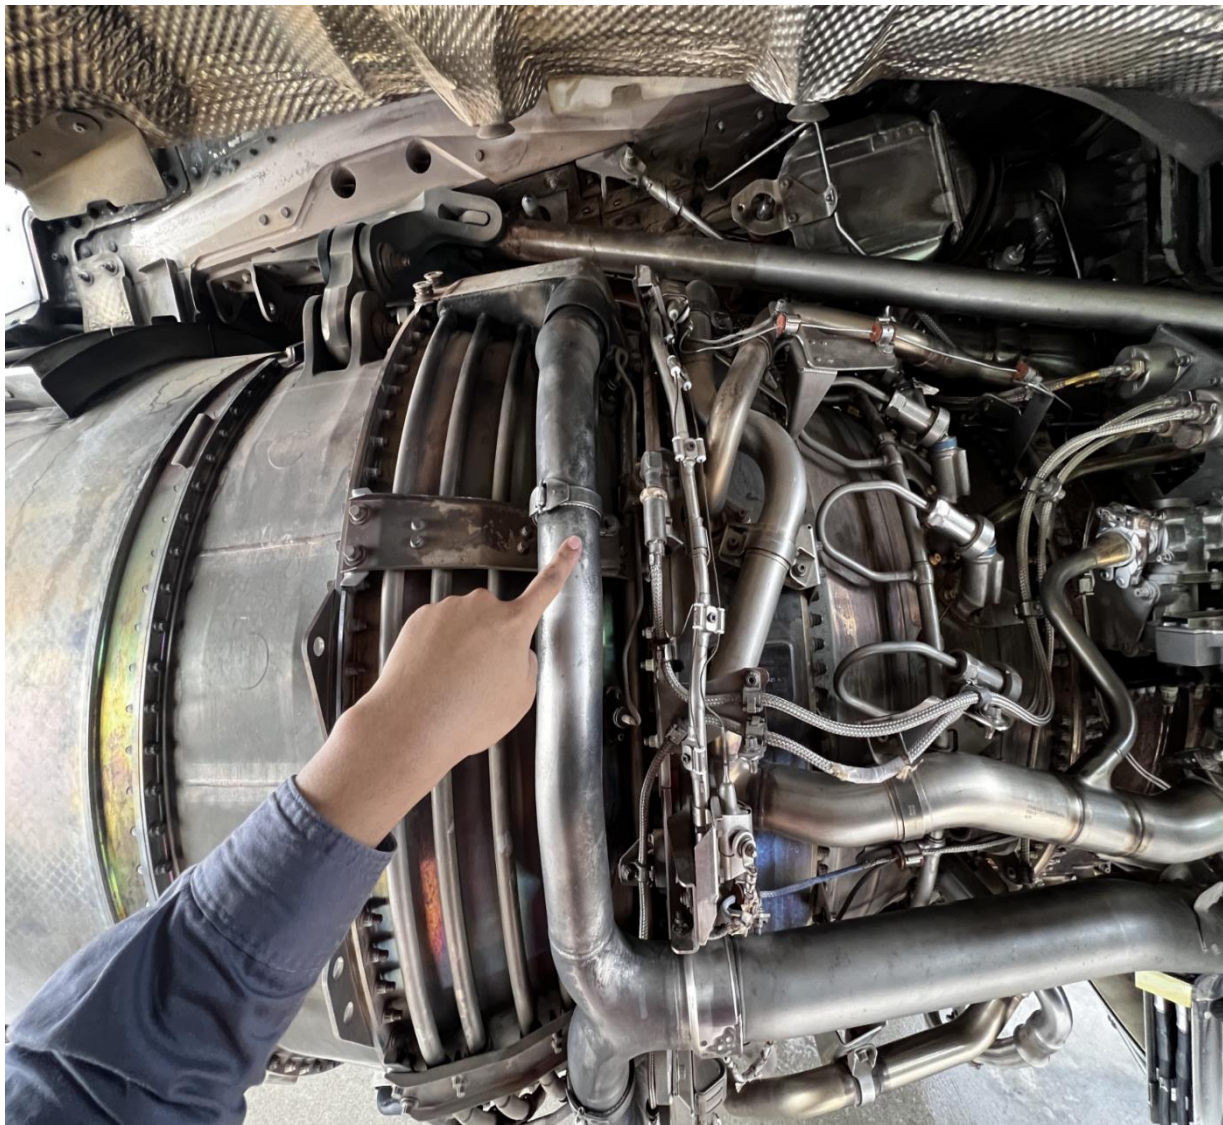
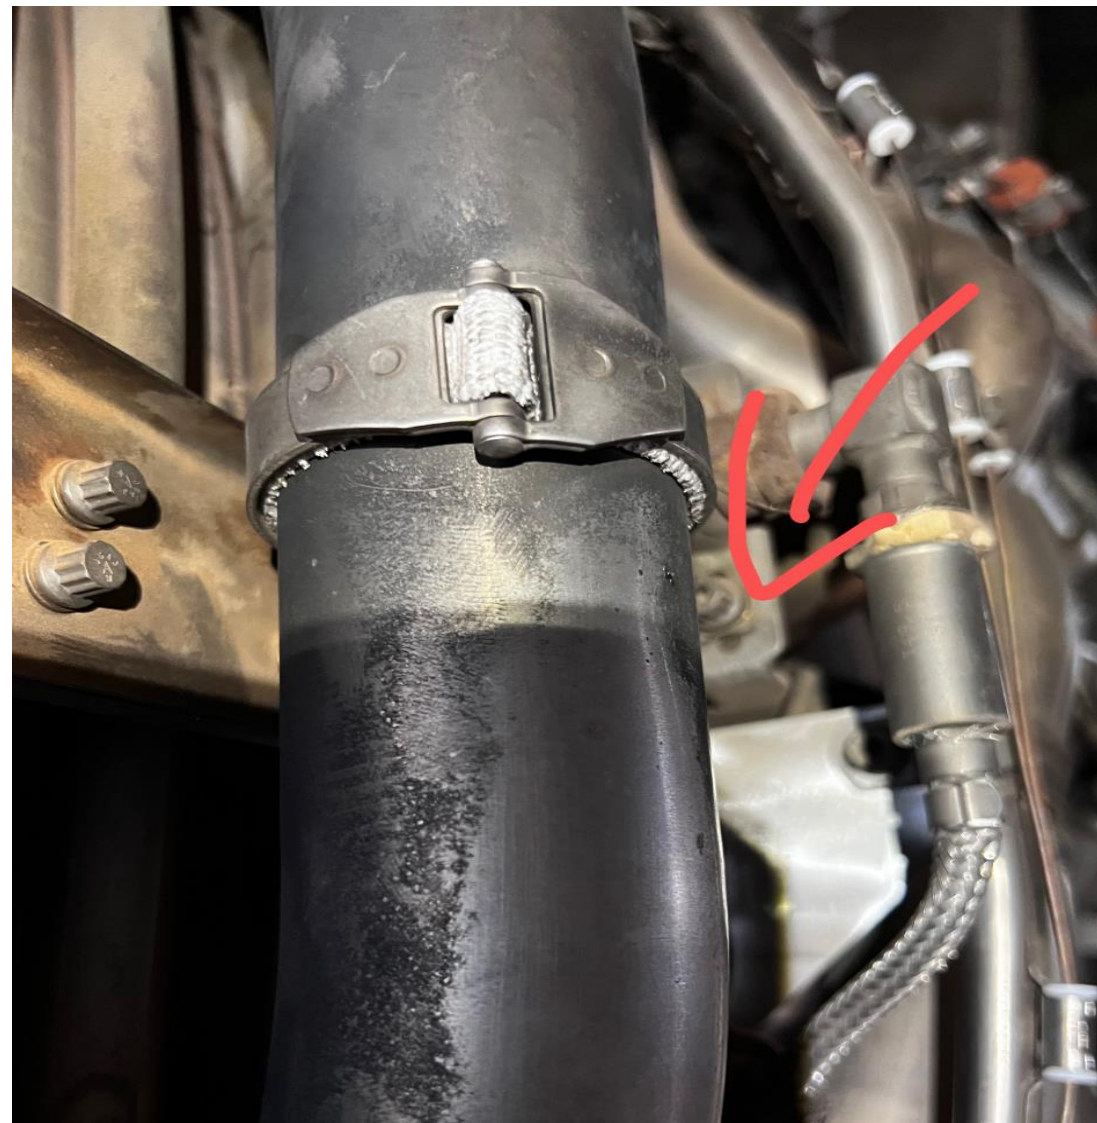
近期某飞机检查发现右发右侧LPTACCV气管有凹坑，借此案例将标准核实方法进行介绍。

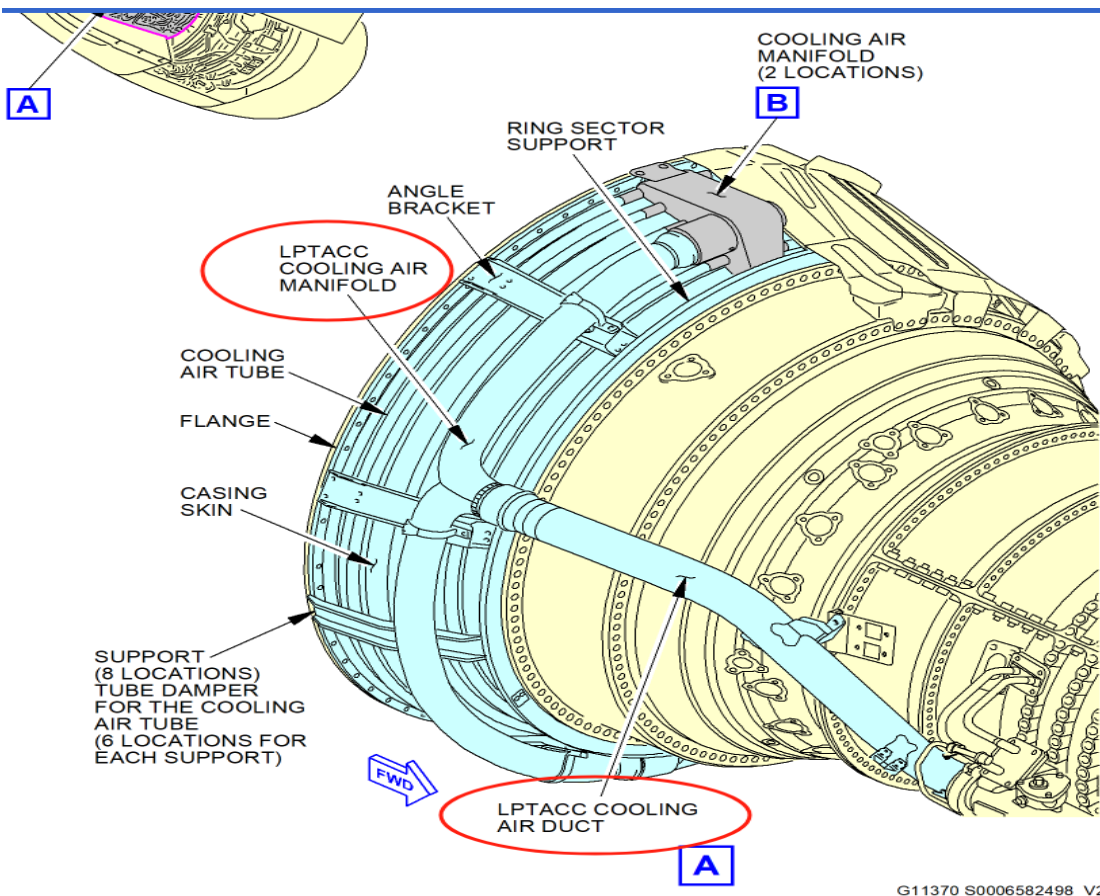
Figure 601. Low Pressure Turbine Case Inspection : Sheet 1

核实标准时要注意区分损伤是在manifold 和 duct，避免用错标准。具体标准对应如下（下述截图仅用于案例讲解，实际标准核实请以现行有效手册标准为依据）

(11) Look for damage on the LPTACC cooling **air manifold:**

- (a) Cracks in the tubes
  - 1) No cracks are permitted.
- (b) Dents and collapse
  - 1) All dents and collapse are permitted if depth is not more than 5 percent of the outer diameter of the tube.
- (c) Flat area
  - 1) All flat areas are permitted if contour change is not more than 5 percent of the tube.

(12) Look for damage on the LPTACC cooling **air duct:**
