737NG货舱地板损伤处置与修理

海技北分区域波音技术组

2023.09.05

近期多架飞机出现货舱地板损伤，且安排调回北京修理。此类损伤日常比较常见，因此结合近期案例，将货舱地板损伤处置、补片损伤、修理方案等进行梳理介绍。

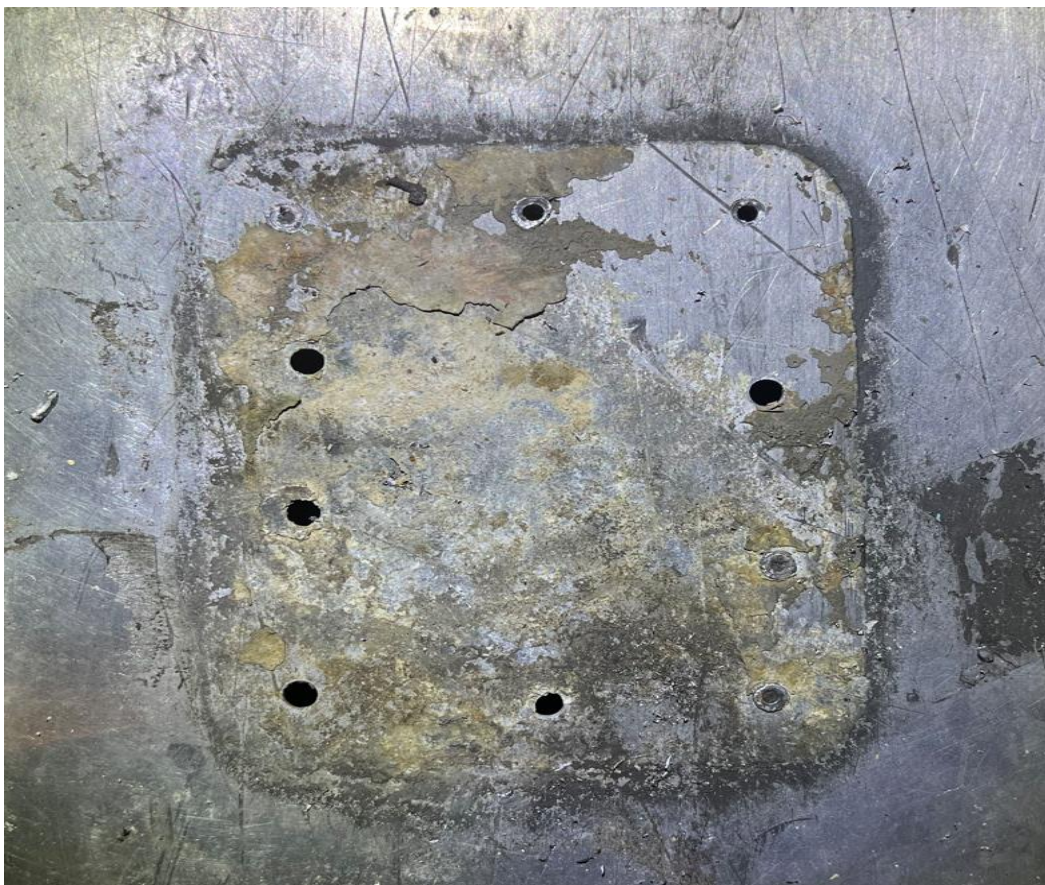
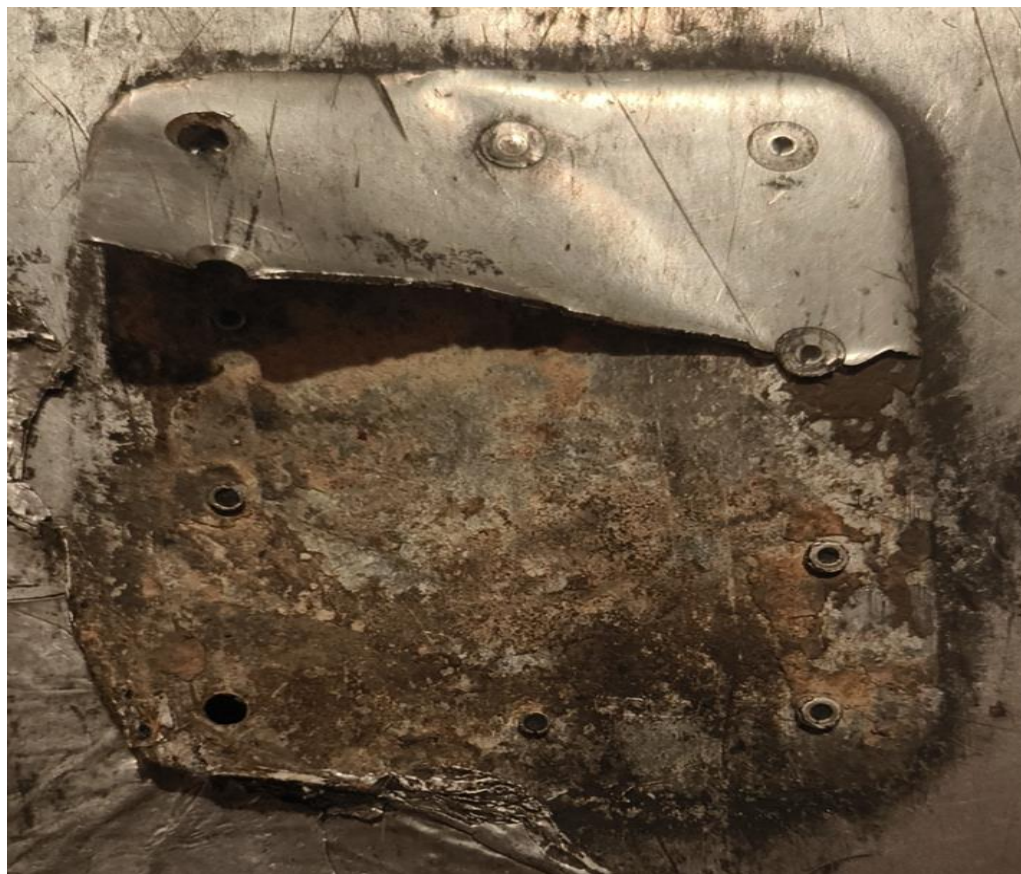
损伤核实——补片、修复区域再损伤

对于补片或修理区域再次损伤的情况，因当前部件状态不再是原始出场状态，不可以直接应用SRM进行标准核实，此情况需和结构工程师或厂家进行一事一议评估。

注：按目前经验，上述情况通报厂家的结果基本就是立即修复，厂家基本不会通过偏离申请。
